5. WATERSHED CHARACTERIZATION

Opelika Engineering On-site Septic Disposal Systems (OSDS) Assessment of Trailer Parks in Opelika

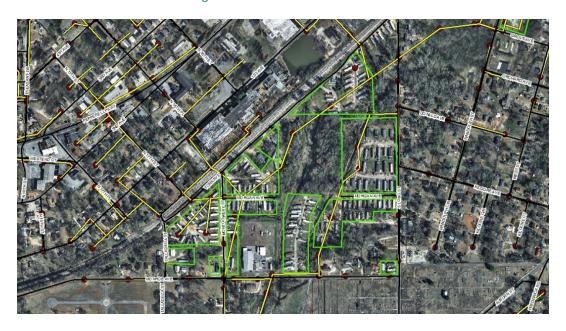
Figure 36: Williford/Hardaway Trailer Park.

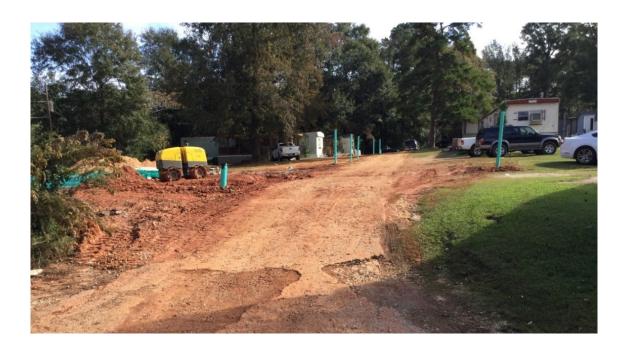
Opelika Engineering On-site Septic Systems in the Watershed

The City of Opelika evaluated other areas that homes might be on septic systems and has also confirmed 14 homes on Sutton Way and 16 homes on Cunningham Court are on septic systems. The City of Opelika also worked to estimate OSDS locations in the Rocky Brook Creek area along Morris Avenue where there are larger acreage homes. Evaluating whether homes are on septic systems is a timely process of which actual suspect addresses and homeowner names must be provided to the Lee County Public Health Department to verify. John Harris, Opelika Engineering has been working closely with the Lee County Public Health Department, Senior Public Health Environmentalist on this issue, but the areas in question are older subdivisions. According to Lee County Public Health they don't have any maps that show septic locations in the county. All septic tanks permitted since about 2003 are in a computer database that could be searched by address by the Lee County Public Health Department. Anything built before 2003, unless it is located in a subdivision would be filed by the owner or applicants last name and the year installed. Nikki met with John Gwin, John Harris, Case O'Dell, and Scott Parker and evaluated all of the GIS layers the city had to try to identify homes in the watershed without sewer service, thus the homes would have septic systems. Additional homes without wastewater were found within the watershed, as shown in Figures 39-40.
